Valley View Farm: Main House

Valley View Farm Main House

Cartersville, Georgia

Historic Structure Report

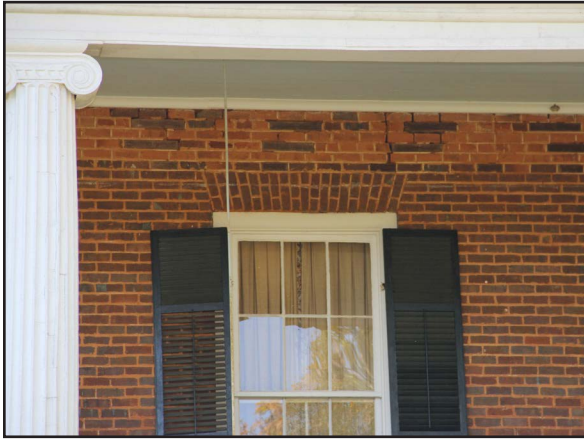
figure 2.16: brick courses at top of I-house portion appear to be salmon bricks interspersed with wooden bricks, “nailers,” possible to attach an entablature.

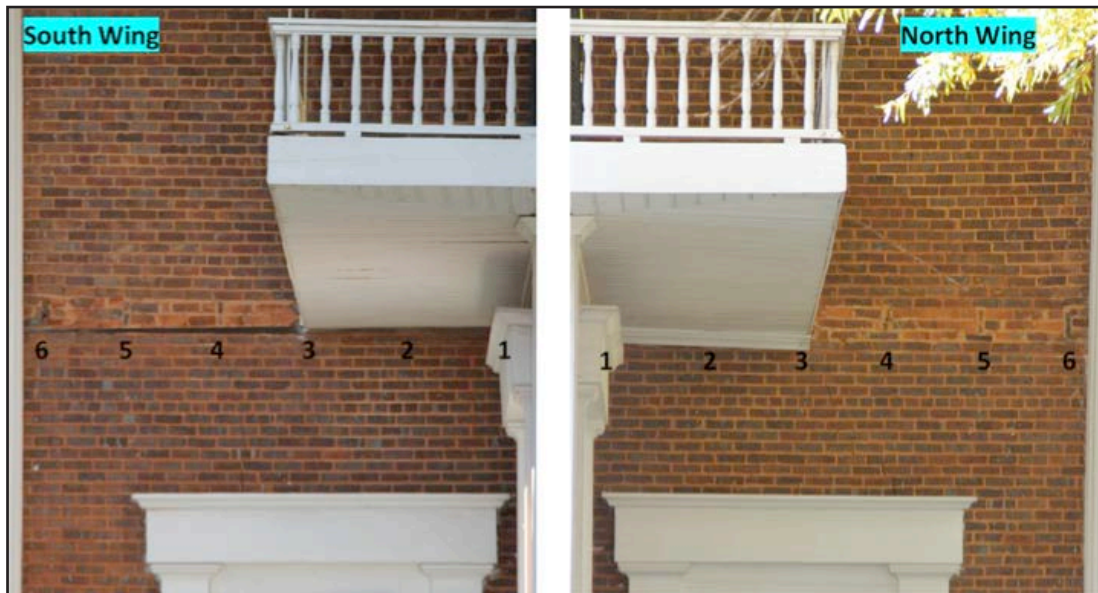
figure 2.17: Side-by-side comparisons of the east-facing gable walls.

Balcony ceiling trim: Trimwork covering where the balcony meets the east-facing wall is present on the north side but not the south. At the bottom edge of it is a paint ghost mark on the wall going all the way to the porch edge. It cants downward as it extends away from the house side. The south side has this same mark, but the trim piece is missing.

Brickwork above the salmon brick courses: Both sides have brickwork above the salmon courses that differs from brickwork below it. This was created by gaps in time in the building/renovation phases. The north side brick wall shows three different appearances, while the south side shows only two. The phases for these brick walls can be seen as: phase one—the building of the first story; phase two was only about a few weeks or so later—the bricking in of the gable ends; and phase three was the large renovation that removed the trim from the north brick gable end and extended it to its present location. At some point, the south gable end was removed and the wall extended to its present height. This removed evidence of the second phase on the same south wall and explains why there are no trimwork ghost marks there, as seen on the north side.¹

Boxed lintels above the gable wing doors: The lintels below joists 1-5 are open at the top and designed to require protection from the elements. Because the original roof did not cover these doors, something such as a full-width porch had to have been there.

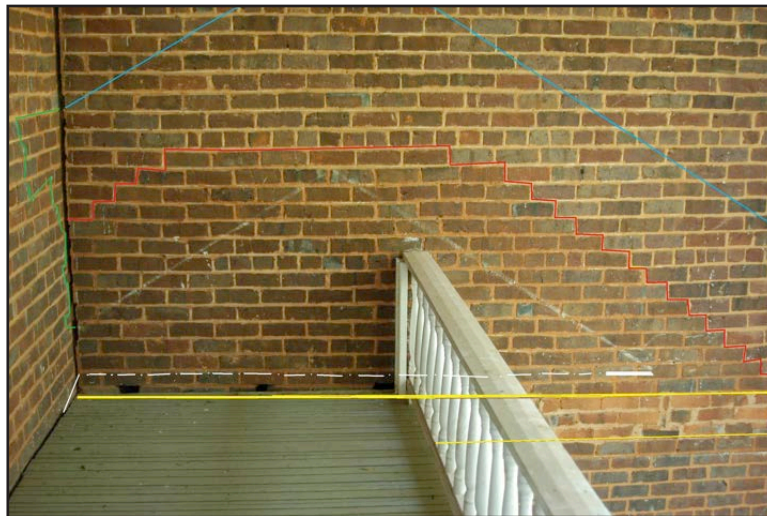
figure 2.18: North side, east-facing gable end wall. Colored lines added.

In figure 2.18, the blue line is the original gable roof. The red line is the top of the original gable brick wall. The white dashed line and white angled line against the I-house wall are a suspected angled piece of flashing. The green line (left) is the paint ghostmark outlining where the cornice and trim abutted the wall. The white *painted* line is the actual paint ghostmark at the bottom of the frieze. The top yellow line is the top of the salmon brick courses. The bottom yellow line is the bottom of the salmon brick courses. The wall to the left is the north-facing wall of the I-house section, second floor. The gap barely seen between the I-house wall and the balcony floor is a 1 ½" recessed brick course intended for tucking the

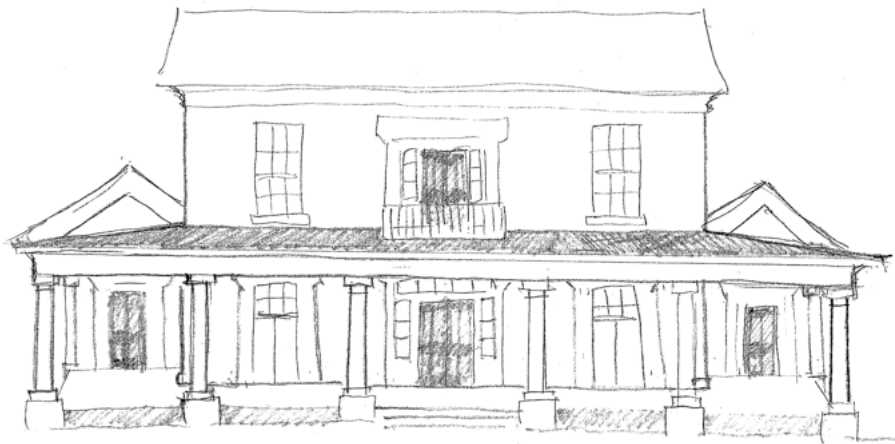
figure 2.20: artist's sketch of possible original configuration.

The above is an artist's concept of the most likely original appearance of Valley View at the time of original construction. The large entablature upon which rests the edge of the porch roof is based on the back porch design, which is believed to be original. The small upper balcony incorporated into the porch roof is highly likely, based on the fact that the upper door (known to be original) would probably have had a balcony as depicted. ¹⁰

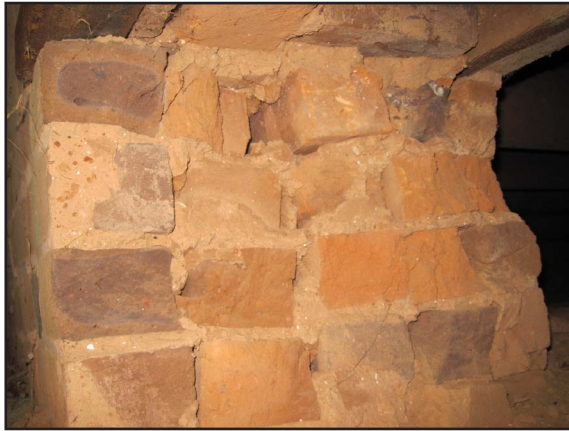
The main house is structural brick, with 18" walls (five wythes thick) below the first floor joist and 12" (three wythes thick) walls above and throughout the house. In figure 3.6, one can see just the metal lintel over the crawlspace opening under the south wall of Room 103 (Edith's Parlor). Below that is the veneer wythe of brick, and to its right are the other four wythes. In the upper right corner the wood sill that supports the floor joists is visible.

figure 3.6: Five wythes of brick form the foundation.

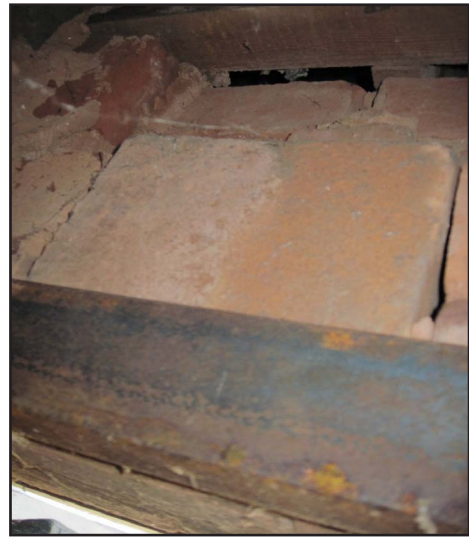
figure 3.7: 8" x 8" brick in place.

In figure 3.7, looking up at the metal lintel in figure 3.6, one of these square bricks is visible in place. See also figure 3.8 below.

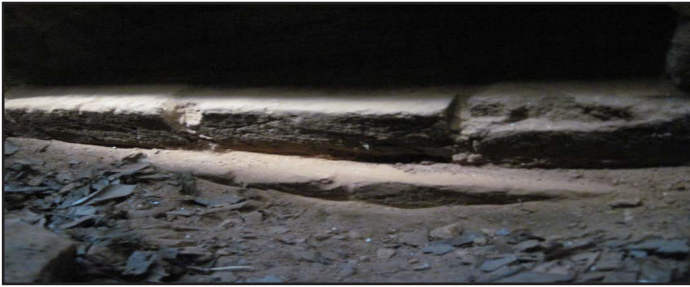
figure 3.10: Spread footer of foundation showing.

It is suspected that the brick foundation extends 2-5' below grade with a two-course spread brick footer (*see fig. 3.10* taken at the entrance to the north crawlspace under Room 102).

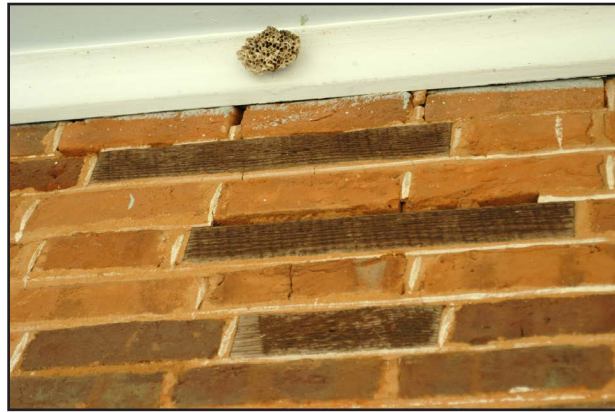
White penciling is still evident on some of the mortar lines on this façade (fig. 3.18).

figure 3.18: penciling of the mortar lines visible at the very top of the east façade, and wooden bricks—nailers—where cornice trim was originally attached.

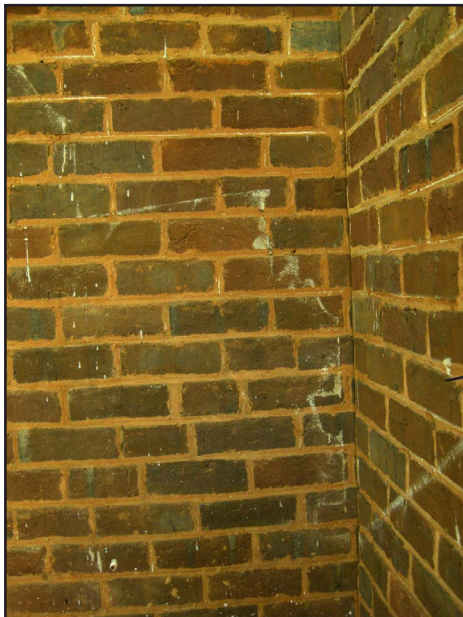
(above) figure 3.19: northwest inset corner of front balcony, top arrow points to ghost mark.

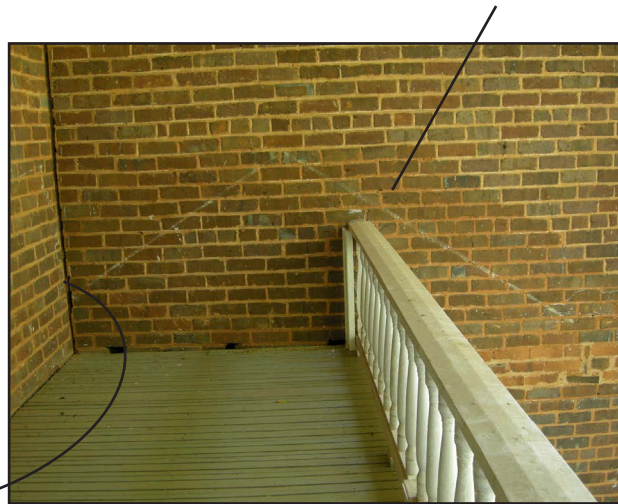
(left) figure 3.20: cornice profile ghost mark.

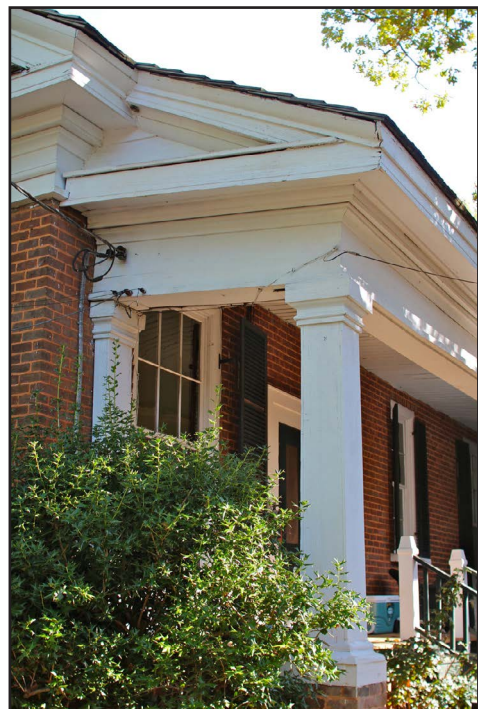
figure 3.30: porch roof on north wing, entablature and ceiling tilt downward.

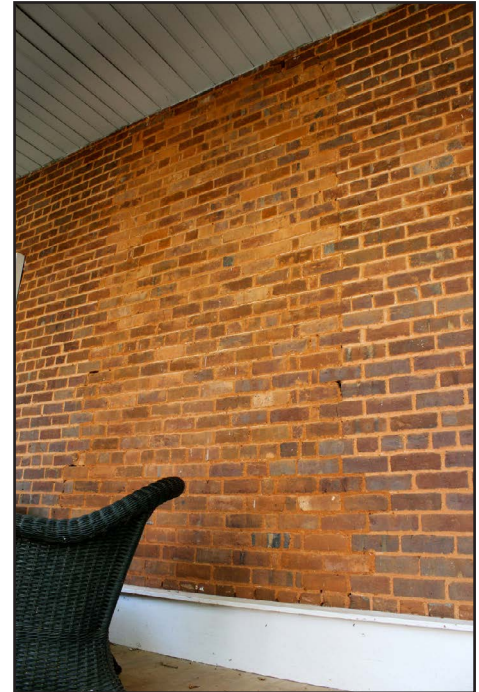
figure 3.31: Porch wall outside Room 105, showing filled in window.

that once opened onto the back porch is visible in some cracking in the plaster that was patched long ago, but this remodeling is most noticeable from the exterior where the bricks do not exactly match the original masonry (*see figure 3.31, p.53*).

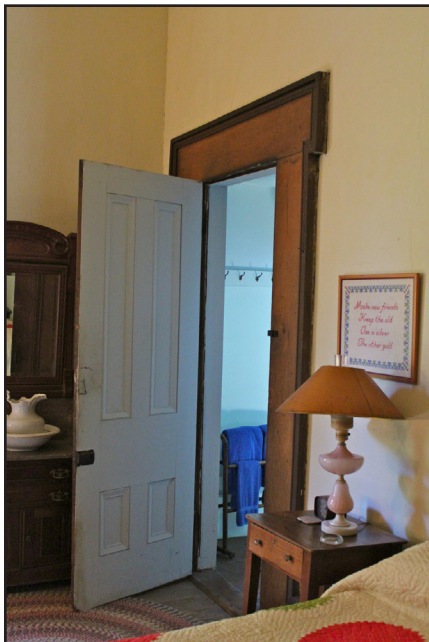
figure 3.70

What was once a closet to this room is now a pass-through between rooms 105 and 106. There is a built-in bookshelf with four shelves and hooks for clothing or towels. At some point a doorway was cut through to Room 106, with plain board trim attached (*fig. 3.70*).

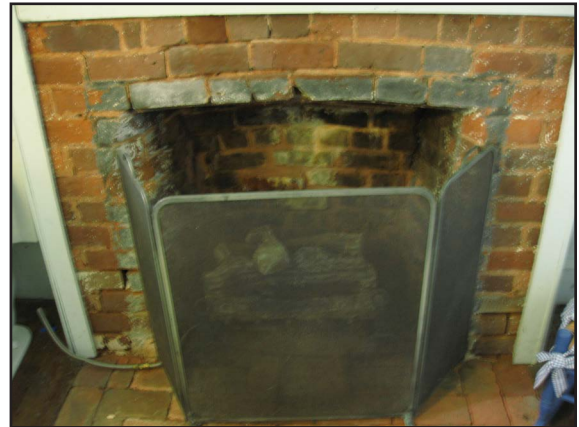
figure 3.72

This room and closet is entirely painted the same light blue: ceiling, walls, trim, and mantel. The doors on the cupboard over the closet door are grained on the back, indicating that this room was no doubt grained, as well. The fireplace bricks are unplastered and unpainted, but a grey ghost outlines the hearth opening, perhaps where a metal covering trapped soot (*mantel: figure 3.44, p.58; closeup: fig. 3.72*).

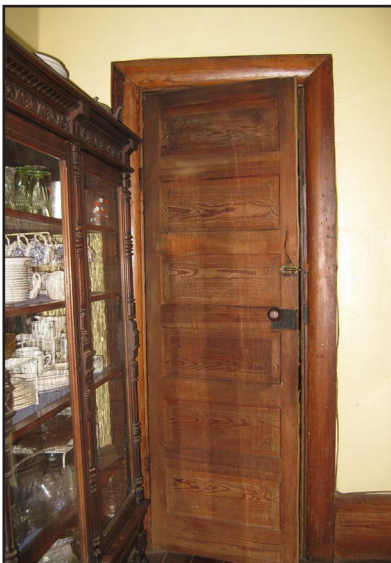
figure 3.74: 20th century door.

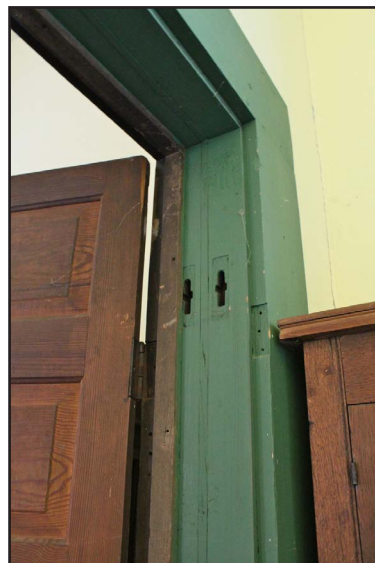
also different. It consists of simple curved and mortised boards, similar to the exterior casing around the windows. The jamb also exhibits the pulleys from a double hung window on either side (see *fig. 3.75*). The family said that this was not originally a window in the house, but the parts came from a window, perhaps the one that was taken out of Room 105.

figure 3.75: door jamb fashioned from window casing

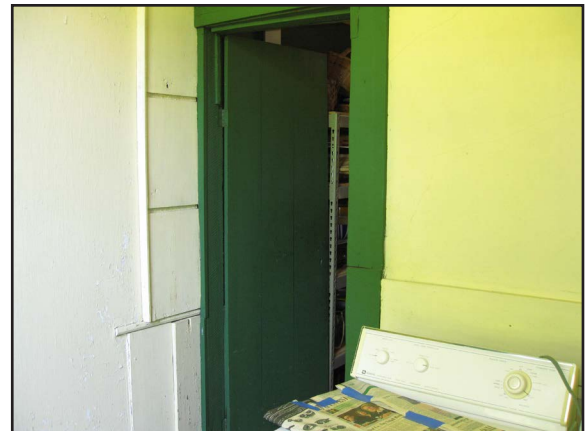
figure 3.78: door cut through previous built-in shelving in Room 109

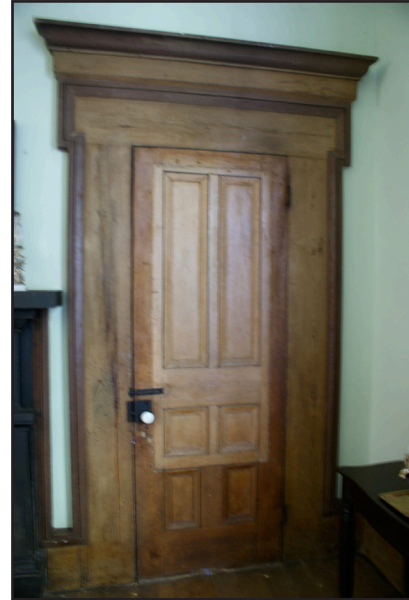
figure 3.82: door between Rooms 111 and 109, portion of door has been replaced transforming it into a 6-panel door.

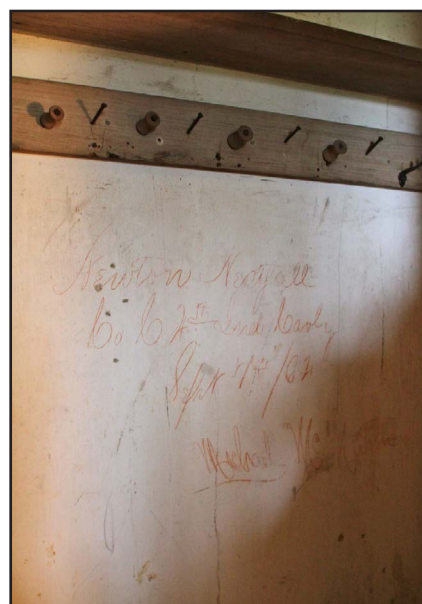
Another historic aspect of Valley View is the graffiti in the closet in this bedroom. During the stay of Federal troops at the plantation, two of them left behind their signatures on the inside wall of the cupboard. This has never been painted over and can still clearly be seen today (*fig. 3.88*).

figure 3.88: Inside of closet in Room 202, notice the spools used to protect clothing from the nail "hooks" and a Union soldier's graffiti on the plaster.

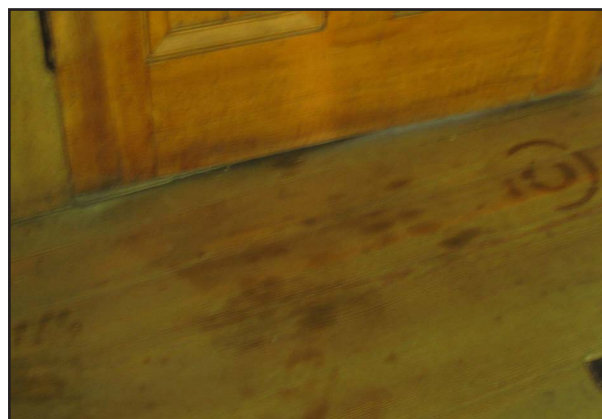
There is also evidence that some sort of poor quality incompatible clear coating was inexpertly brushed onto the doors and trim at a later date. There are small drips and sags evident (*fig. 3.51*), and perhaps even the signature of the workman himself in the form of hand-prints and a bucket print on the unfinished floor of the Yankee bedroom (see *fig. 3.87, p.75*).

figure 3.87: handprints on floor, Room 202.

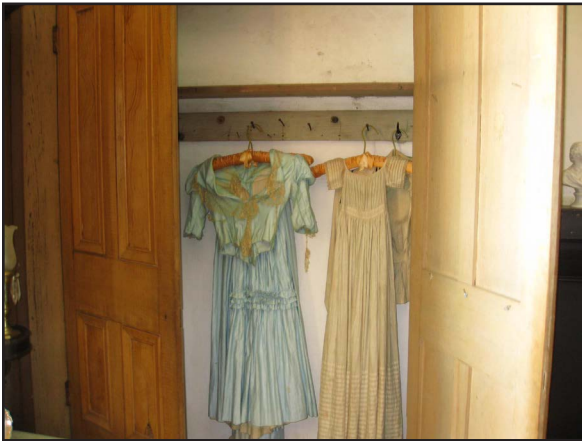
figure 3.90: Room 203 closet interior.

onto the balcony, one on the east wall and one on the south wall. There is a mantel on the west wall with a shallow closet to the left. The closet, like that in Room 202, is grained on the outside and coated with a light wash inside that shows the grain (*fig. 3.90*). Because some hardware is missing, we can see that there is a lighter coat underneath. There is a nailboard and shelf, also

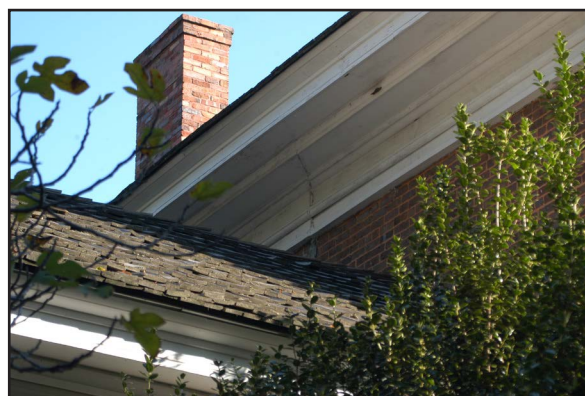
figure 3.93: rebuilt chimney on I-house section.

All appear to be original, although the two in the I-house section appear to have been rebuilt above attic floor level (see figs 3.93 and 3.94). The chimneys have flush tooled mortar joints, even in the attic, where they are not highly visible, indicating high quality craftsmanship that is characteristic of the initial building phase (fig. 3.95).

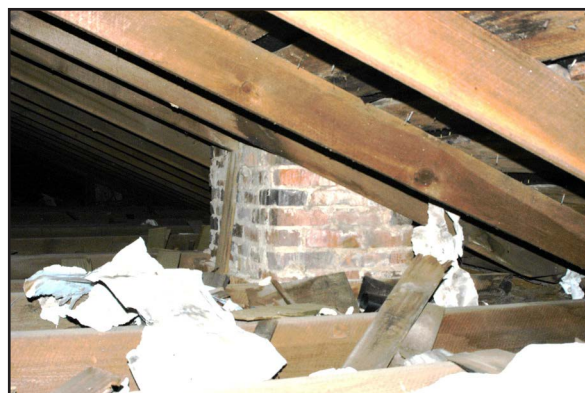
figure 3.94: attic portion of chimney with brick rebuilt.

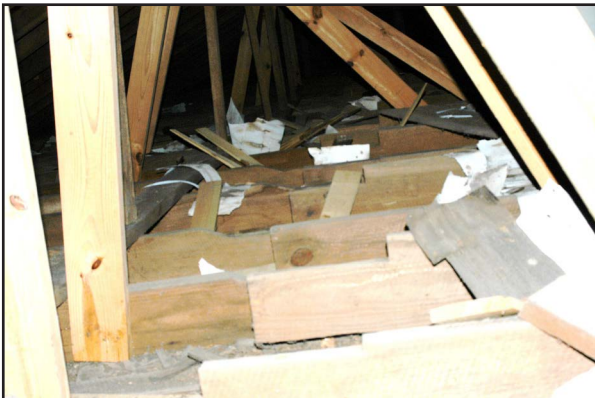
figure 3.100

rafter plates and rafters were removed from the east side and moved outward to the porch entablature when the roof was expanded to cover the porch (*see fig. 3.100*).

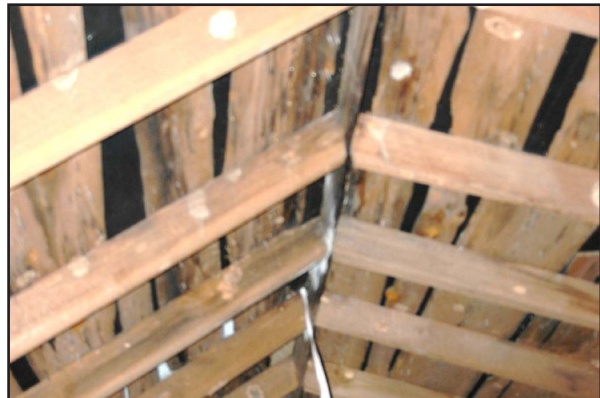
figure 3.101: ridgeboard of Attic 301 and historic decking.

Rafters are 2" x 6" boards secured to the rafter plate on the attic perimeter. They form a hip roof of about 30 degrees and meet at the ridge board (about 50' long) in the center (*see fig. 3.101*). Many collar beams, diagonal braces and knee braces prop up the sagging ridge board in an ad hoc fashion. The iron or steel balcony rods are seen in 301 and are secured to the joists. Their ends are threaded and they are secured in place by threaded nuts. (*see fig. 3.102*).

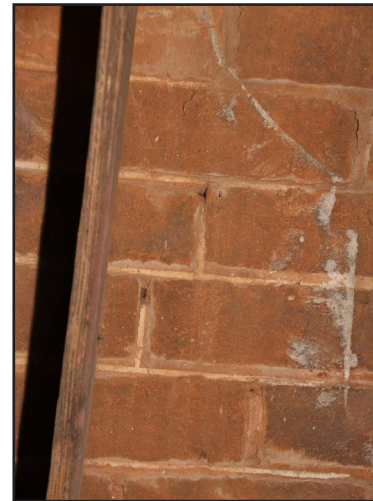
figure 3.105

Inspection has led to the conclusion that this was not, however, the original appearance of the back porch roof. Ghost marks of the cornice molding in the attic against the western wall of the I-house section show that the eaves of the wings abutted this wall (*see fig. 3.105*). This is similar to the ghost mark found on the front porch balcony level, except that it does not include the frieze, only the cornice. There is no room for a frieze above the 302A and 303A decking and the eaves. There are also no nailers there to support a frieze. This evidence, penciling on this same western wall found inside Attic 301A (*fig. 3.105 again*), and the partially covered window on the stair landing indicate the historic exposure of the west wall of the I-house section. The original porch most likely did not have the current shed roof, but may have been covered by the same decking still seen nailed to the joists and possibly covered with sheet metal roofing. This would leave only a shallow pitch to the roof, which is still seen today in the tilt of the porch ceiling.

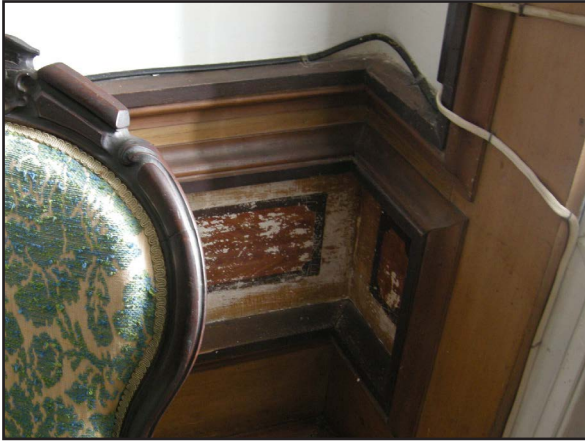
figure 3.112: wires running up, over and along the trim and wainscot in Room 100.

The electrical wiring sometimes runs conspicuously down the wall from a hole in the ceiling, and a few of the outlets and switches are surface applied to some of the interior trim (*see fig. 3.112*). Other than these locations, the utilities are hidden fairly well. Use of the crawl-space and attic were used when possible.

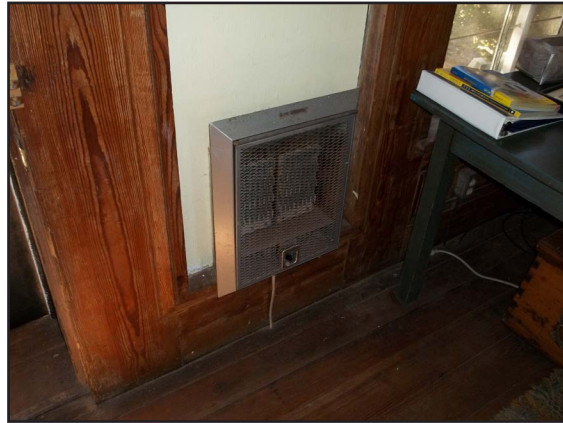
figure 3.113

The mechanical system for Valley View consists of package air conditioners for cooling, complemented by LP gas and electrical heaters for heating. Room 111 (Dining Room) utilizes a 220V electrical heater for warmth (*fig. 3.113*). In the next room is a Frigidaire package air conditioner used for cooling. The LP gas feeds two fire places in the house. A pressure regulator for this system was located on the south side of the I-house section (*fig. 3.114*).

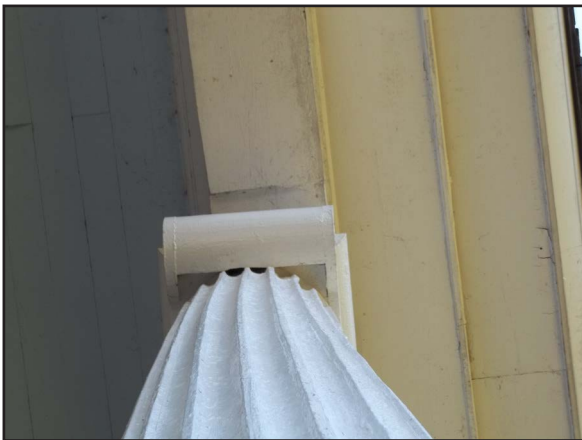
figure 4.2, figure 4.3 (below): both images show bowing of front columns.

The columns were an area of major concern during the site review. Tapping on the column confirms that the exterior is made up of relatively thin staves, with the interior being hollow. These columns are typically loadbearing, with the weight of the entablature spread out among the staves by the cap. The paint on the wood column surface is in poor condition in spots (*fig. 4.1*). These tongue and groove column pieces will deteriorate rapidly without adequate paint coverage, especially on the bottom 6". Several of these columns also appear to bow when looking at them from a distance and when sighting up the columns towards the roof (*fig. 4.2*). Because of the critical nature of these columns, a high priority needs to be placed on their repair and continued conservation so that they can continue to carry the roof load. The bases of the columns are made up of several pie-shaped wedges of wood. Some of these bases are in good condition (*fig. 4.4*), some are in poor condition or missing altogether (*fig. 4.5*). Under these thin wood bases are brick bases and, like the columns, some are in better condition than others. Some appear structurally solid, and others are crumbling (*fig. 4.6*). The columns and bases that need the most monitoring and attention are the two immediately north of the main entrance door. The half columns on the northern and southern ends of the house are in best condition; this may be due to increased ventilation permitted by the gap between the wing wall and the column interior. The Ionic capitals on the top of all of the columns are in good condition. There is some cracking of the paint, but the wood beneath appears to be sound.

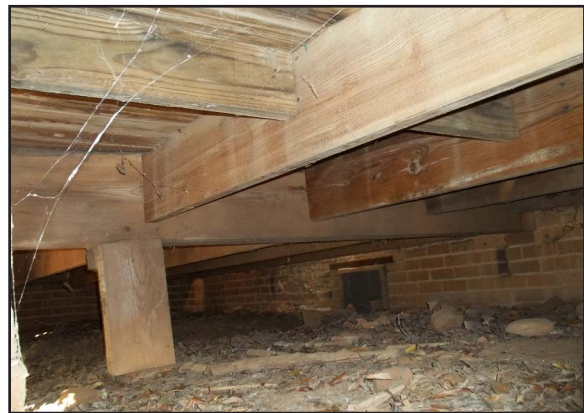
figure 4.7: foundation underneath porch.

The front porch is largely intact, but there is an occasional loose board. The diagonal corner joints at the north- and southeast corners appear particularly troublesome as they have numerous wire cut nails added to prevent curling. The remainder of the porch is attached with machine cut nails. There are also several areas of the porch floor that have missing paint and flaking paint. The floor boards themselves are in good condition. The sub-framing under the porch is in good condition; no rotten or otherwise deteriorated wood was found (*fig. 4.7*). However, there are numerous places where the floor framing has been buttressed by the addition of dry stacked block and, in some cases, wood “piers” underneath the porch (*fig. 4.8*). These piers were obviously deemed necessary due to sagging – the span of these joists between beams is exceedingly long. The use of dry stacked block and brick present problems because it is not permanent nor stable in nature. The use of wood is particularly problematic because by coming in contact or even being so close to the ground it encourages termite infestation.

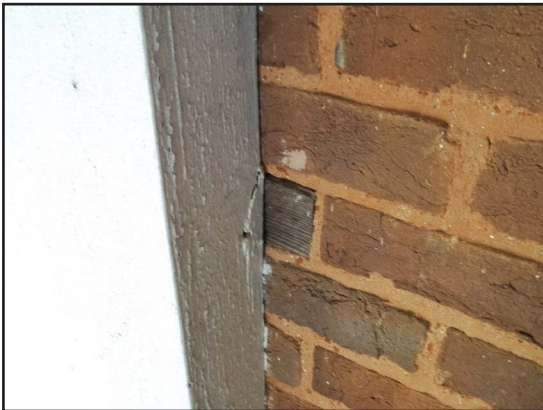
figure 4.10

The door surrounds on the front of the house are in good condition. No soft spots were found when probed with an ice pick around the edges. Paint on these door casing pieces is badly alligatored, although it is still uniformly adhered to the wood. The surrounds are still anchored firmly to the structure on this elevation—they are tight against the masonry and do not lean out at the top like some of the other surrounds. The wood nailers laid within the masonry wall are visible in some areas. There is a worn appearance to them, probably due to UV radiation, but they are still solid and do not show any signs of rot or infestation (*fig. 4.10*).

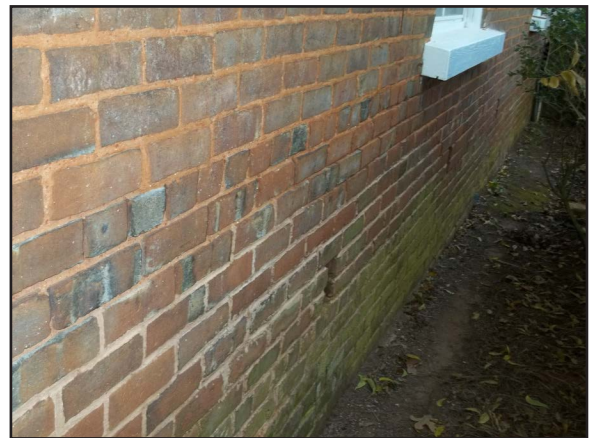
The north facade of the north wing masonry is also in good condition. There is evidence of slight mortar damage due to rain starting at window sill level. There is also a separation crack that occurs at the left hand side of the jack arch over the window (*fig. 4.11*). This is due to differential settlement at the foundation. The foundation has not been undermined in this location despite moist conditions. There is mold on the lower foot of the wall created by the moist conditions there (*fig. 4.12*).

figure 4.12: mold on masonry near the ground.

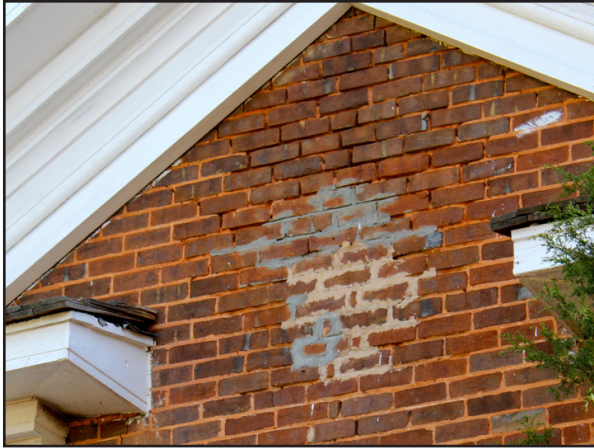
figure 4.13: patched mortar in gable of south wing.

the lime mortar that has washed out with both Portland mortar and what looks to be some type of gray epoxy (*fig. 4.13*). On each wing, the central portion of the gables is worn most. The middle portion of the wall shows slight wear almost all of the way down to the ground. The gable and return trim on these gable ends is in good condition and exhibit no visible signs of decay.

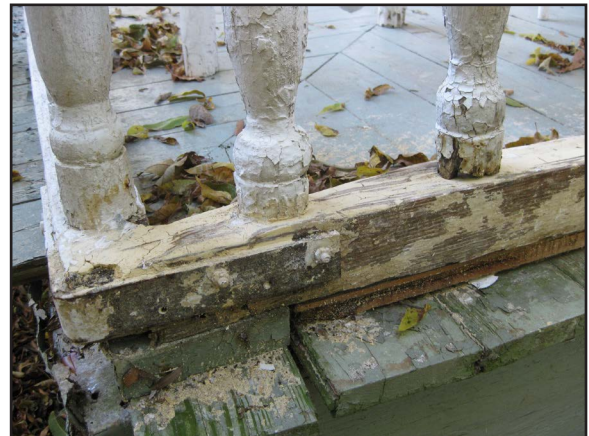
The overall condition of the exterior paint is quite good, save for the spots mentioned above (the porches, front handrails, front door casings, and portions of the handrails and columns), which one would expect to receive the most exposure to the elements. Although the family has been diligent over the years in keeping the house painted, insufficient preparation and too many coats of paint can also contribute to deterioration. There has been water damage from leaky roofs at times, particularly on the back porch. Column bases are often the hardest to keep coated and protected from rot. As the column bases have been replaced by brick, except for the pilasters on either side of the front porch, this is not a grave issue anymore and the family has tried to repair what rot has developed. The first floor front porch is in the most need of paint (*fig. 4.18*). Several coats can be seen flaking off and the family is repairing rotted balusters with wood filler on the northeast corner of the porch (*fig. 4.19*).

figure 4.19: wood filler on railing

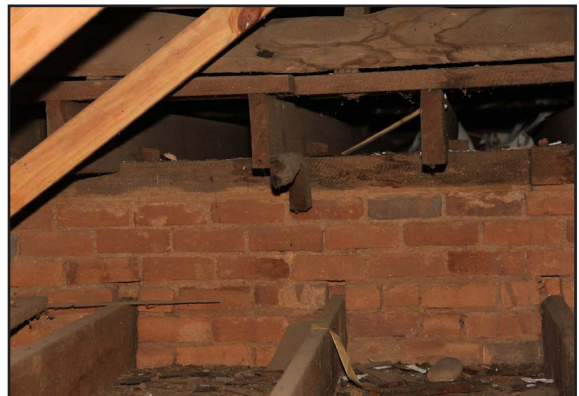
figure 4.20

The access point for Attic 301 is unsafe and difficult to get to, discouraging routine inspections. It is located where the roof is close to the ceiling joists, by the back, northwest corner of the upper balcony. There is little headroom at that point and attic nail points protrude dangerously close to one's head through the roof decking.

Access to Attics 302 and 303 requires squeezing through the soffit area, limiting entry to thin people and hampering practical, routine inspections and emergency extraction in case of injury. (*see fig. 4.20*).

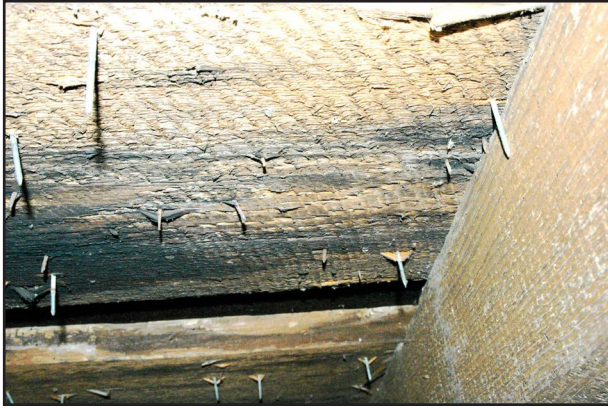
figure 4.21: mold on rafters in attic.

There is no ventilation in the attic, which may present a humidity problem. There appear to be some mold on rafters and decking (*see fig. 4.21*).

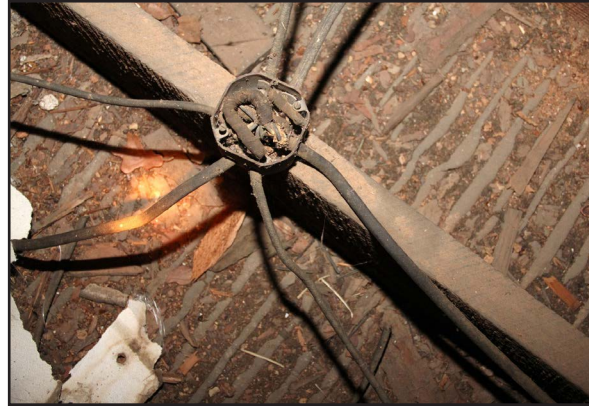
figure 4.22: open junction box, Attic 302.

Open junction boxes (code violation) are in 303, 302 and 301A. The wiring is a round, black rubber, older type. One frayed section was noted in 302 (*see fig. 4.22*). Attic 301A has a modern wire repaired with black electrical tape (*see fig. 4.23*).

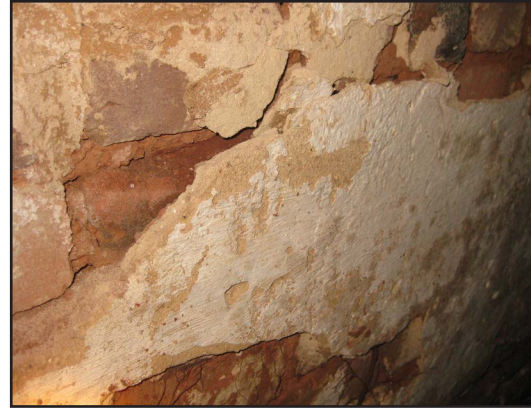
The plaster covering the low inner wall of bricks is crumbling and separating from the brick. (*fig. 4.25*) There are some step cracks in the brick and mortar, brick spalling, and mortar eroded, especially at the entrance. There is evidence of powder post beetle and termite damage—though limited and inactive—on the support beams, door, and door frame. The root cellar is currently filled with discarded items, making it difficult to evaluate completely.

figure 4.25: plaster deteriorating in root cellar

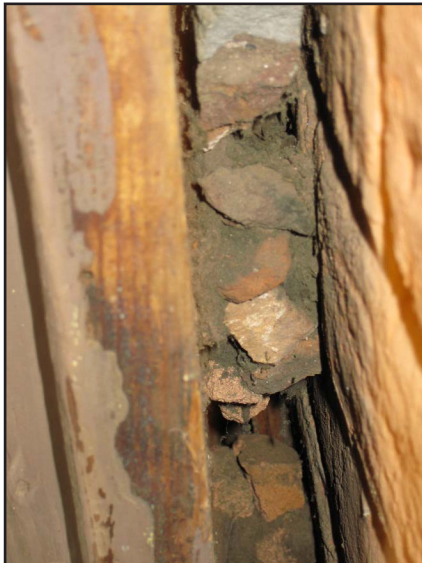
(far left) figure 4.34: Room 104 mantel pulling away from wall.

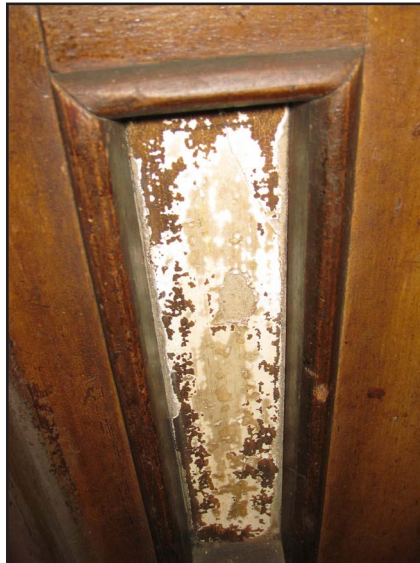
figure 4.35: Room 104 scuffed and flaking faux painted wainscot.

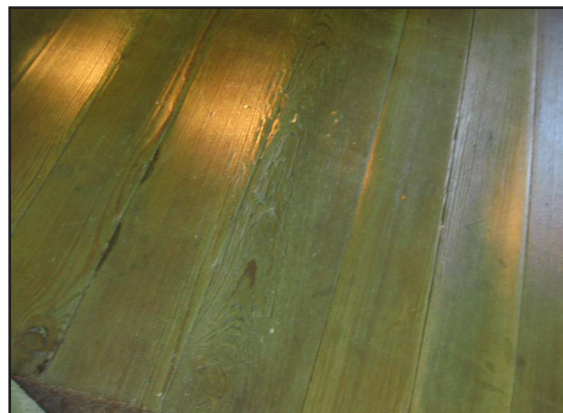
figure 4.41: Room 111

There are brown spots on the ceiling in the northwest and northeast corners indicative of water damage, a plaster crack on the wall above the door leading to room 101 (front porch), peeling paint on the ceiling, two cracks on the wall above the door leading to room 107 (back porch), and a crack on the wall above the door leading to room 109 (laundry). The sill of the north window is worn down to the bare wood and slightly warped, evidence of sun and water damage (*fig. 4.44*). There is warping of the floor boards adjacent to the fireplace (*fig. 4.41*).

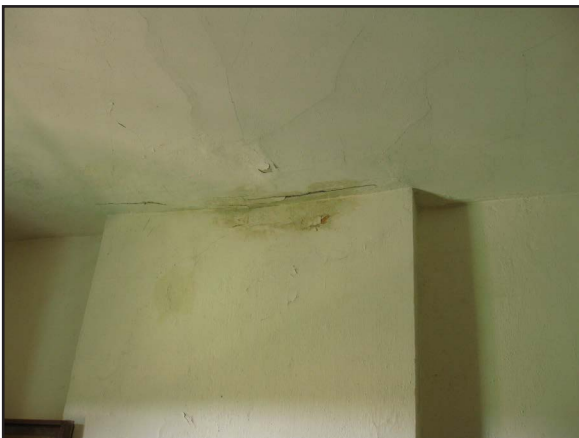
figure 4.46: Room 203

This room also shows previous water damage, particularly on the ceiling around the chimney where the plaster is discolored, splitting and bulging (*fig. 4.46*). There are also cracks in the wall above the door, the east window, the south window and multiple cracks on the ceiling. The door to this room has suffered damage, as well. The upper east panel has a vertical crack. The top trim piece is missing from this panel on the inside; all the trim pieces for this panel are missing on the outside (*fig. 4.47*).

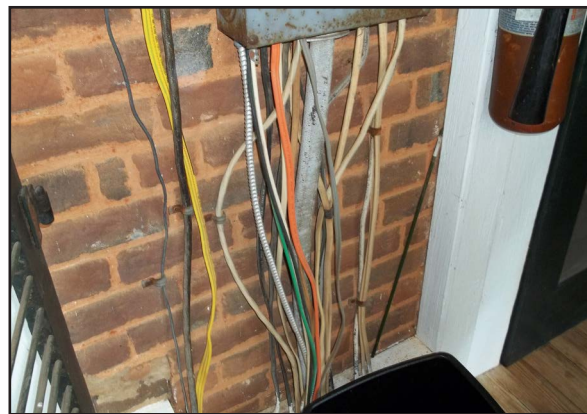
figure 4.48

The electrical system is made up of an assortment of conductor types, junction boxes, switches, and duplex outlets (*fig. 4.48*). Overall, the system was installed and updated piecemeal over the years as indicated by the inconsistent use of conductors and electrical boxes.

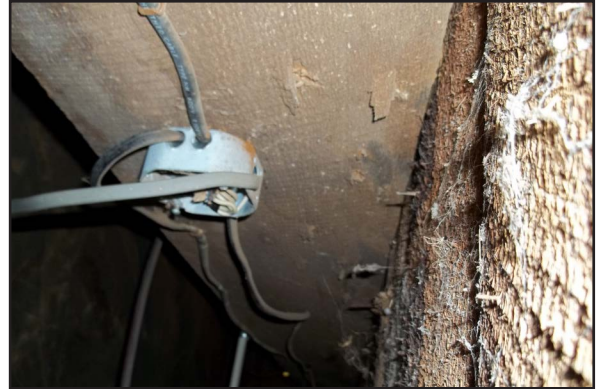
figure 4.49

Most of the conductors are non-metallic, commonly called Romex. They are old and brittle. In both the crawlspaces and attic, many of the junction boxes are uncovered (*fig. 4.49 and figure 4.22, p.98*). Despite these issues, there are no detectable problems with the electrical systems. All circuits appeared to work and there were no tripped breakers in the breaker panel, which would indicate a short circuit.

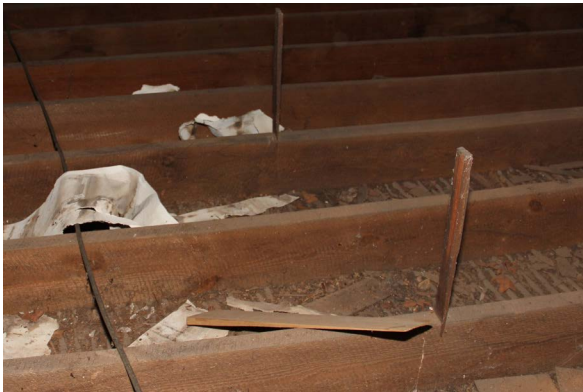
figure 5.5: shims sticking up from joists in attic.

Cut off the shims in the joist cuts because they present a tripping hazard (*see fig. 5.5*). The cuts may present no threat to the building but should be monitored or clad with bridging material.

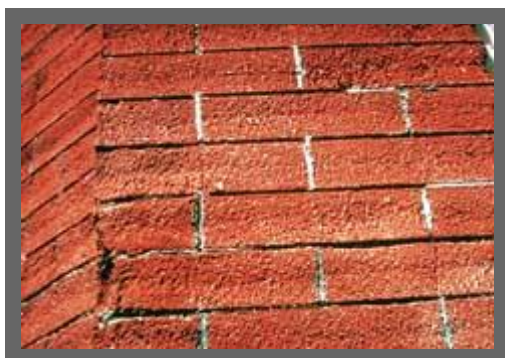
Abrasive cleaning methods include all techniques that physically abrade the building surface to remove soils, discolorations or coatings. Sandblasting has permanently damaged this brick wall. Photo: NPS files

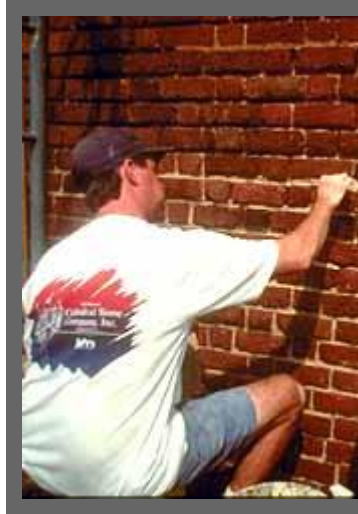
Mortars for repointing should be softer or more permeable than the masonry units and no harder or more impermeable than the historic mortar to prevent damage to the masonry units. This early 19th century building is being repointed with lime mortar. Photo: John P. Speweik.

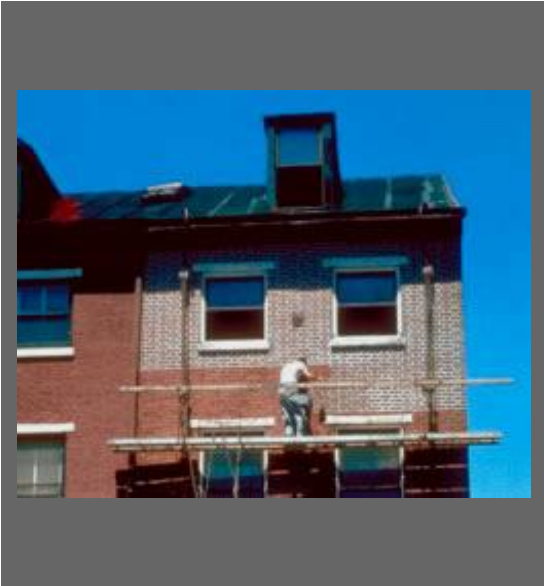
Some aspects of a building's visual character are fragile and are easily lost. This is true of brickwork, for example, which can be irreversibly damaged with inappropriate cleaning techniques or by insensitive repointing practices. The historic character of this front wall is being dramatically changed from a wall where the bricks predominate, to a wall that is visually dominated by the mortar joints. Photo: NPS files.
